# Contribution of 3D and 7D BIM to the Diagnostic Assessment of the Former National Council of Shippers of Benin Building (G + 4) in Cotonou

Kassa Issifou Mounou Sambieni<sup>1,2\*</sup>

<sup>1</sup>National Public Works Testing and Research Company (SNERTP), Cotonou, Benin

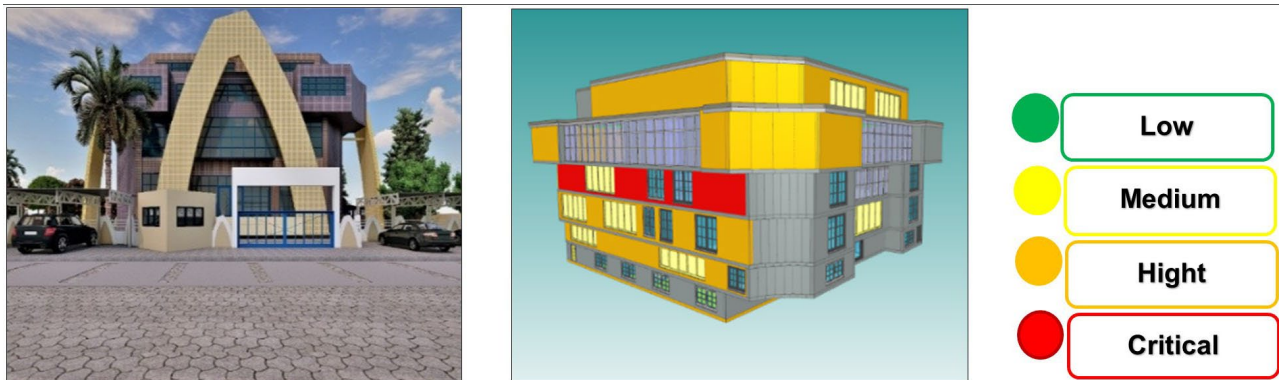
**Figure 7.** 3D rendering of the digital model (left) and the diagnostic model (right).

ization of the defects across four criticality levels shown in **Figure 7**, providing an immediate spatial overview of the structure's condition.

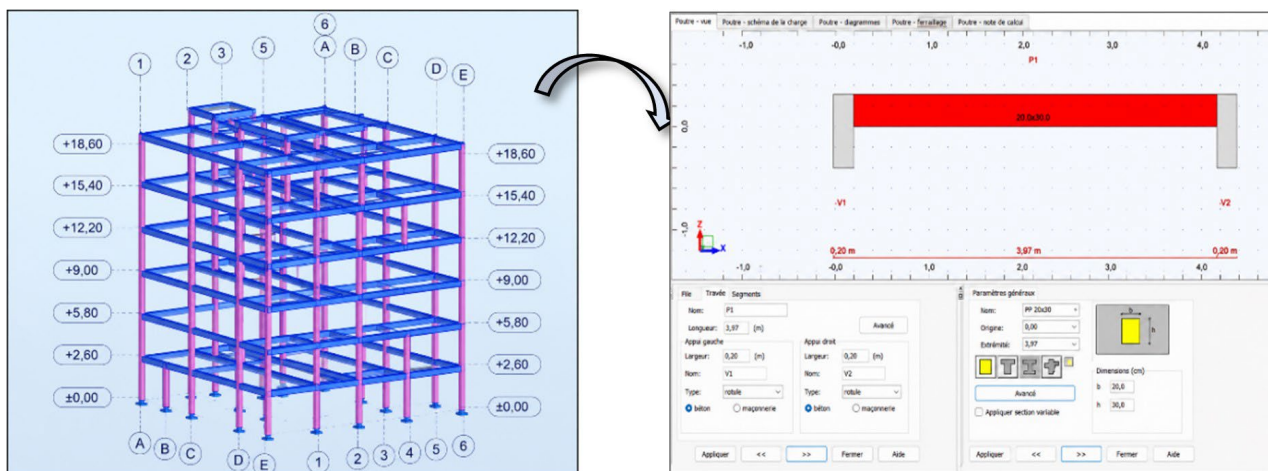
**Figure 8.** Analytical model of the building and the beam under study in Autodesk Robot Structural Analysis.

The building's analytical model of **Figure 8**, obtained via transfer from the Revit model, represents the geometry of all load-bearing elements columns, beams, and floor slabs across the structure's six levels. Only the beam supporting the glass canopy at level R + 4 and its associated column underwent a full structural analysis; the resulting internal force diagrams showing bending moments and shear forces of **Figure 9** were extracted for the ultimate limit state.

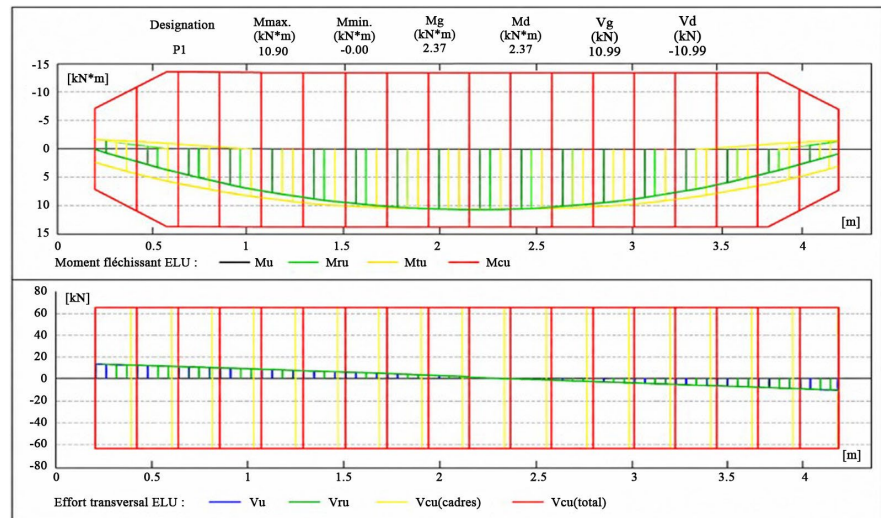
**Figure 9.** Moment and force diagrams at the Ultimate Limit State (ULS) for the beam under study.

The bending moment diagram confirms a maximum moment at mid-span, consistent with the expected behavior of a statically determinate beam subjected to a uniformly distributed load, while the shear force diagram shows a symmetrical linear distribution with maximum values at the supports.

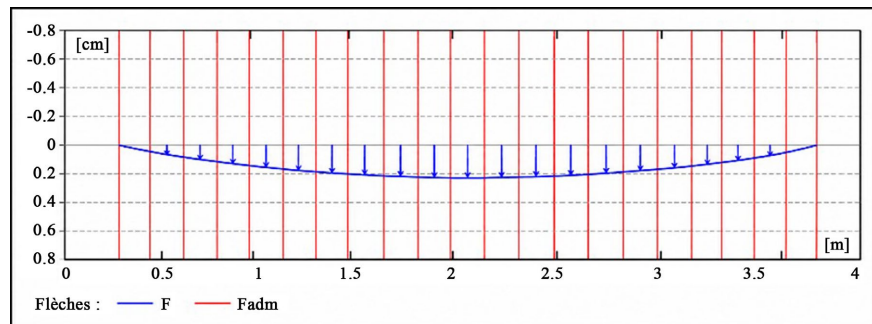
**Figure 10.** Total deflection and permissible deflection.

Furthermore, the deflection check confirms that the calculated total deflection remains within the permissible limit across the entire span as it is shown on **Figure 10**.

This compliance with serviceability limit states suggests that the deterioration observed on site stems more from reinforcement corrosion caused by chronic water ingress than from excessive deformation of the element.
