# Wall Paintings of Giresun, Yağlıdere, Tekke Village, Sari Halife (Hacı Abdullah Halife) Mosque, Türkiye

The Hacı Abdullah Halife Mosque is located in Tekke Village, Yağlıdere District, Giresun, Türkiye. The present study documents the building and its wall paintings, evaluates its architectural fabric and later interventions, and reassesses its chronology and decorative attribution through measured survey, photographic documentation, documentary sources, and comparison with regional mosques. Field documentation and measured drawings were used to record the current condition; published historical and art-historical studies, the 1977 protection-board registration record, and the mosque's survey, restitution, and restoration documentation were consulted to distinguish original fabric from later alterations. The mosque is a rectangular masonry building with a wooden ceiling, wooden *mahfil* and furnishings, and a later reinforced-concrete minaret. Comparison with selected nineteenth-century mosques in Giresun and the Eastern Black Sea region indicates that the present architectural form is most plausibly nineteenth-century, although this remains a typological assessment rather than

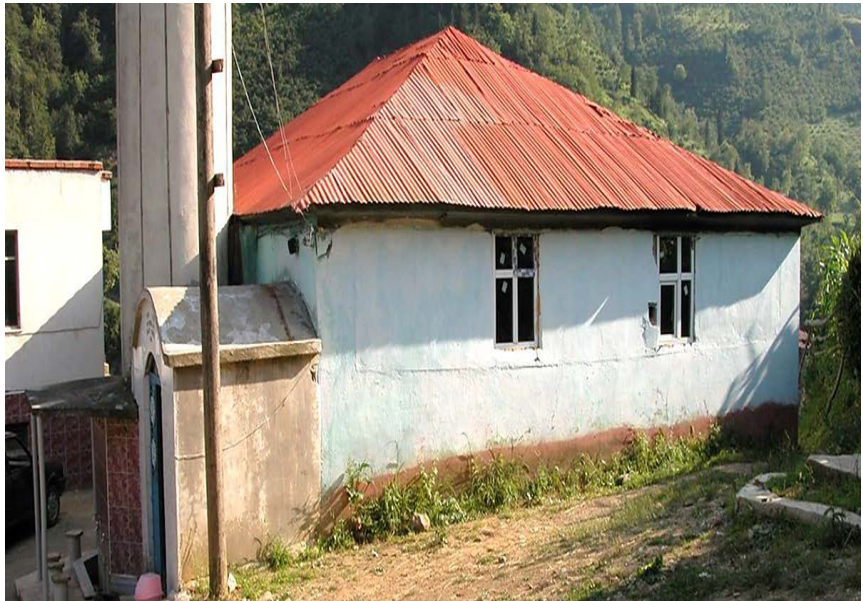
**Figure 2.** Photograph of the mosque from North side (Sedes, 2016).

There are two vertical rectangular windows on the north façade at approximately eaves level (Figure 2). They have simple flat heads and no projecting jambs or separate stone lintels. The wall surface is plastered and painted, with localized cracking, and the façade terminates in a short wooden eave (Figure 3).

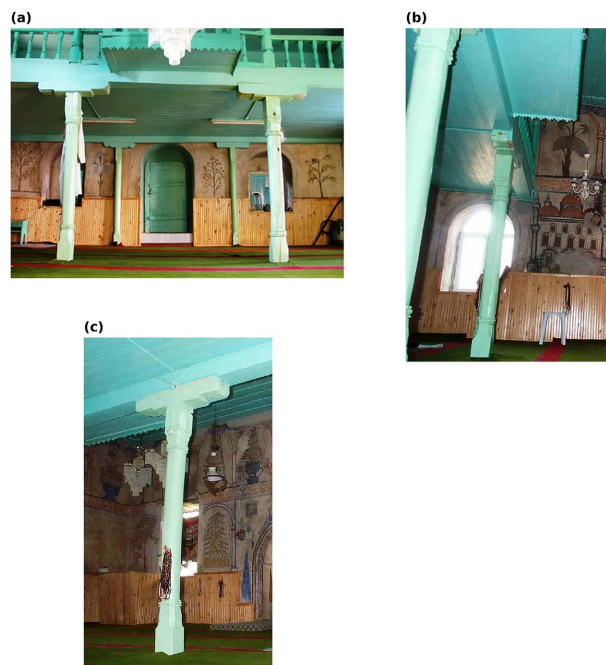
The gallery floor located to the north of the *harim* is completely wooden and extends to the middle of the *harim*. The *harim* has a square-shaped pavilion section that sits on the walls on the sides and two wooden columns in the front. The bases and capitals of the columns supporting the *harim* are square, while the body is round. The transitions from the base and capitals to the body are softened by beveling and made clear with moldings. The railings of the gallery are in the form of wooden railings animated by concave and convex moldings (Figure 9).

**Figure 9.** Gallery floor and wooden columns (Sedes, 2016).

In the interior, there is a door in the middle under the main wall's gallery and a window on each side of the door (**Figure 9**). The door and windows have semi-circular arch openings from the inside. The surface of the main wall above the gallery is solid, and there is a single-winged, simple-workmanship wooden door on the eastern corner of the wall that opens to the gallery (**Figure 10**).

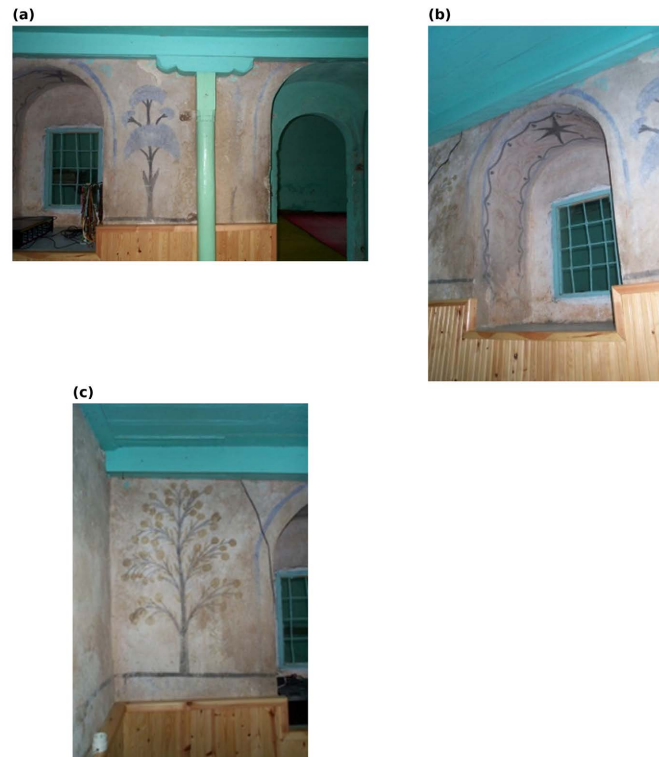
The entrance door is in the middle of the North wall, and a semicircular arched window is opened on both sides of the door. There are two tree motifs on the surface between the entrance opening and the window on the west of the entrance. Since the wooden column carrying the gallery divides the surface in two here, a cypress tree is depicted in the narrow area between the pillar and the door due to its thinness. It is difficult to notice since its color fades over time. The trunk of the tree is brown and the upper part is light blue. A tree motif that can be described as a weeping willow or a ball pine tree with blue leaves clustered in four places is embroidered on the surface between the column and the window. The blue leaves here are stylized. The window is surrounded by an outer contour consisting of a blue line. A zigzag border with dotted corners on both sides surrounds the window niche, and the spaces between the borders are filled with a curved branch motif (**Figure 11**). There is a six-pointed star in the arch. On the surface between the window and the west wall, there is a stylized fruit-bearing apple tree (İltar, 2014b).

**Figure 11.** Wall paintings on the north wall.

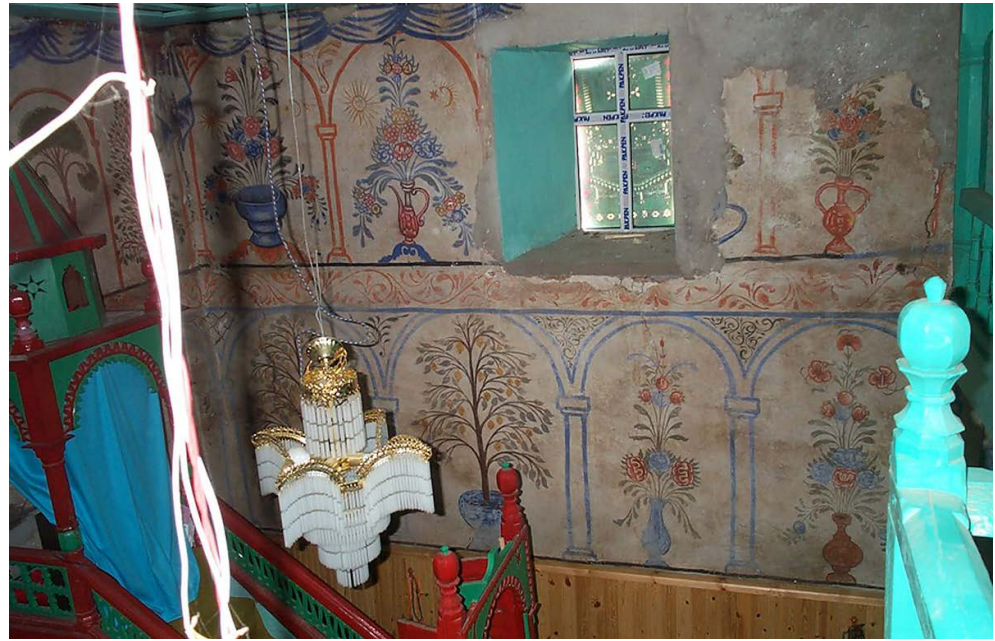
The upper part of the western wall has been damaged by a window that was opened later. Inside the first arch from north to south, there is a bunch of roses coming out of a vase with a high base, bulging body, long neck and handles. The roses are in red and blue tones. The upper part of the rose bouquet has been damaged. Only one blue colored vase handle can be detected inside the second arch, which seems to have been wider. The rest of it has been destroyed (Figure 15). In the third arch, there is a bunch of roses coming out of a pitcher-shaped vase placed on a base similar to an acanthus leaf. The roses are filled on the surface with a composition narrowing from the bottom to the top and clustered in four different places. On the upper levels, there is a moon and star motif to the right of the bunch of roses and a sun motif to the left. The moon and sun are radiating light. On the fourth arch, a cluster of red, blue and pink roses, flowers, tulips and leaves clustered in four places, rising from a vase with a stepped base, a wide body and a wide and open mouth, which sits on a base similar to an acanthus leaf. Black color is used from time to time to add perspective to the leaves in the composition. To the right of the composition is placed the moon and a small luminous sun, and to the left a larger luminous sun (Figure 16).

**Figure 15.** Upper part of the western wall (Sedes, 2014).

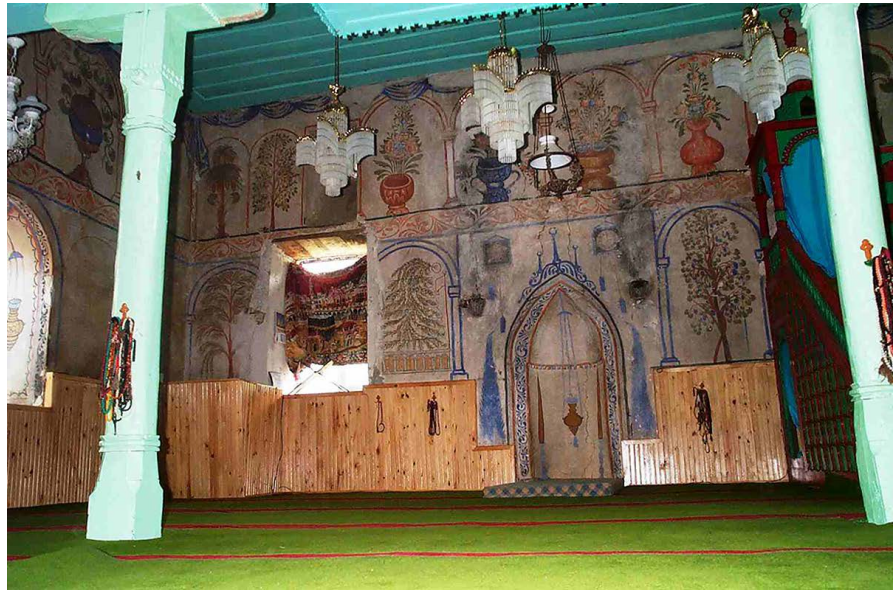
There is a half-round *mihrab* niche in the center of the south body wall of the *harim*, a window to the east of the *mihrab* niche that was later enlarged, and a crenelated opening above the window that preserves its original shape. The original shape of the lower window is the same as the upper one. The pulpit is located between the *mihrab* and the west wall and was built adjacent to the south wall (Figure 17).

Figure 17. South side of the harim (Birleş, 2014).

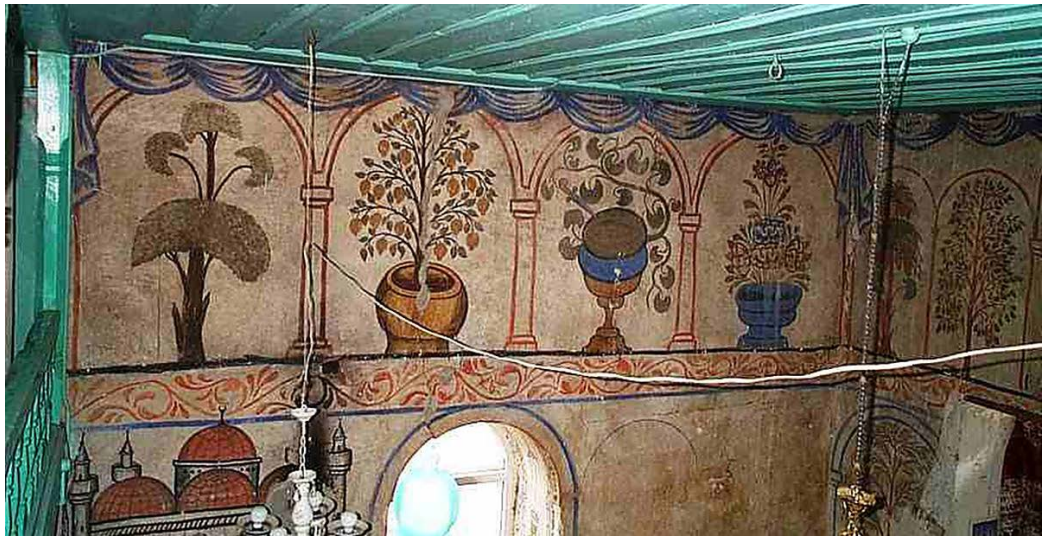
There is one arch eye on each side of the *mihrab*. The western arch eye contains a vine branch with blue grape clusters wrapped around the trunk of a tree; the leaves are green and C-shaped. The eastern arch eye, immediately to the east of the *mihrab*, contains a seven-tiered, eight-gated depiction of paradise. The composition includes the “*livâü l-hamd*” banner, the tuba tree, the gates of paradise, and its successive levels. The *mihrab* niche is centered on the south wall and is bordered by two bands of scrolling branches. The outer band is narrow and appears to have been conceived initially with lozenge forms before being changed to curving branches; the wider inner band is outlined in brown. Above the niche are three finial-like elements set on S- and C-curving supports. A chain from the *mih-*

*rab* arch suspends a hanging oil lamp; two standing candlesticks flank the niche. Two suspended clocks occupy the rectangular surfaces between the *mihrab* and the adjacent arch eyes. Cypress motifs occur at the lower sides of the *mihrab*. Soot around the lamps indicates their historical use before electrification (Figure 20, Figure 21).

Figure 20. East side of the harim (Birleş, 2014).

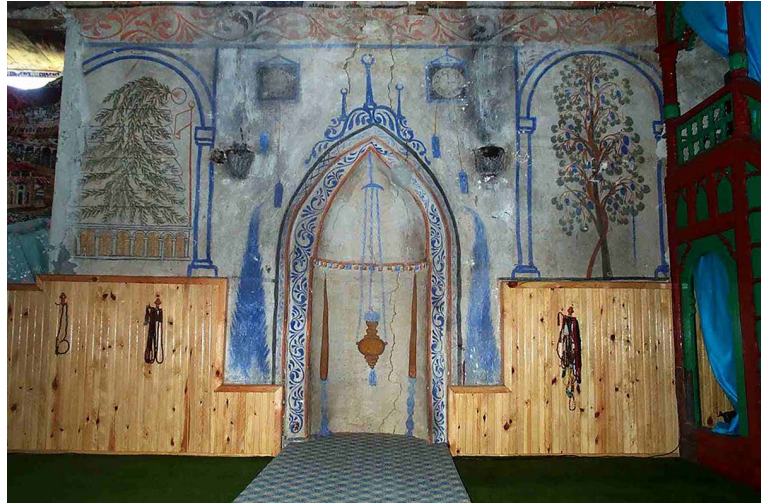
The *mihrab* is a simple semicircular niche located at the center of the south wall. Its two decorative borders, hanging lamp, candlesticks, suspended clocks, and cypress motifs are described above. The surviving painted composition is significant because it combines vegetal ornament with objects and symbolic imagery; the seven-tiered, eight-gated paradise depiction is located in the eastern arch eye beside the *mihrab*, while the western arch eye contains the vine motif (Figure 22).

**Figure 22.** The mihrab (Birleş, 2014).

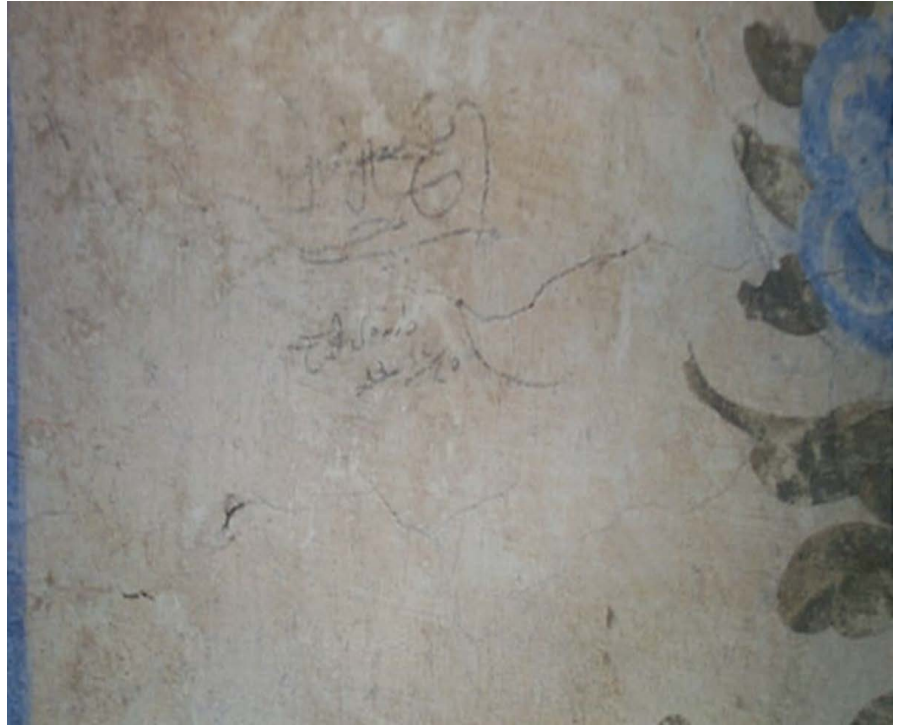
**Figure 26.** The inscription “li Eş-şeyh Hamza” (İltar, 2014b).

The attribution of the wall paintings to *Hacı Hamza* is likewise provisional. The partially legible inscription on the west wall has been read as “*Darendeli Eş-Şeyh Hamza*”; the associated date is too damaged to be read securely. The inscription is therefore evidence for the name associated with the decoration, but identifying that person as the painter is an inference rather than a direct signature statement. The inference is strengthened by comparison with securely documented nineteenth-century regional wall-painting programs, especially the repeated use in Trabzon and neighboring Eastern Black Sea mosques of floral bouquets in vases, trees, architectural frames, mosque depictions, and related object motifs (İltar, 2014b; Sümerkan & Okman, 1999; Yavuz, 2009). However, the sources consulted do not identify a securely attributed surviving regional work by *Hacı Hamza* himself. The safest conclusion is therefore that the decoration can be associated with a *Darendeli Hacı Hamza* on epigraphic and comparative grounds, while the painter attribution remains tentative (Arslan, 2005).
