# Geo-Mechanical Analysis of Landslide-Prone Road Cut Slopes along the National Highway-5, Powari to Akpa, Kinnaur District, Himachal Pradesh, North-Western Himalaya, India

**How to cite this paper:** Deepak, Kumar, S. and Kumar, K. (2026) Geo-Mechanical Analysis of Landslide-Prone Road Cut Slopes along the National Highway-5, Powari to Akpa, Kinnaur District, Himachal Pradesh, North-Western Himalaya, India. *Open Journal of Geology*, 16, 563-576. <https://doi.org/10.4236/ojg.2026.169028>

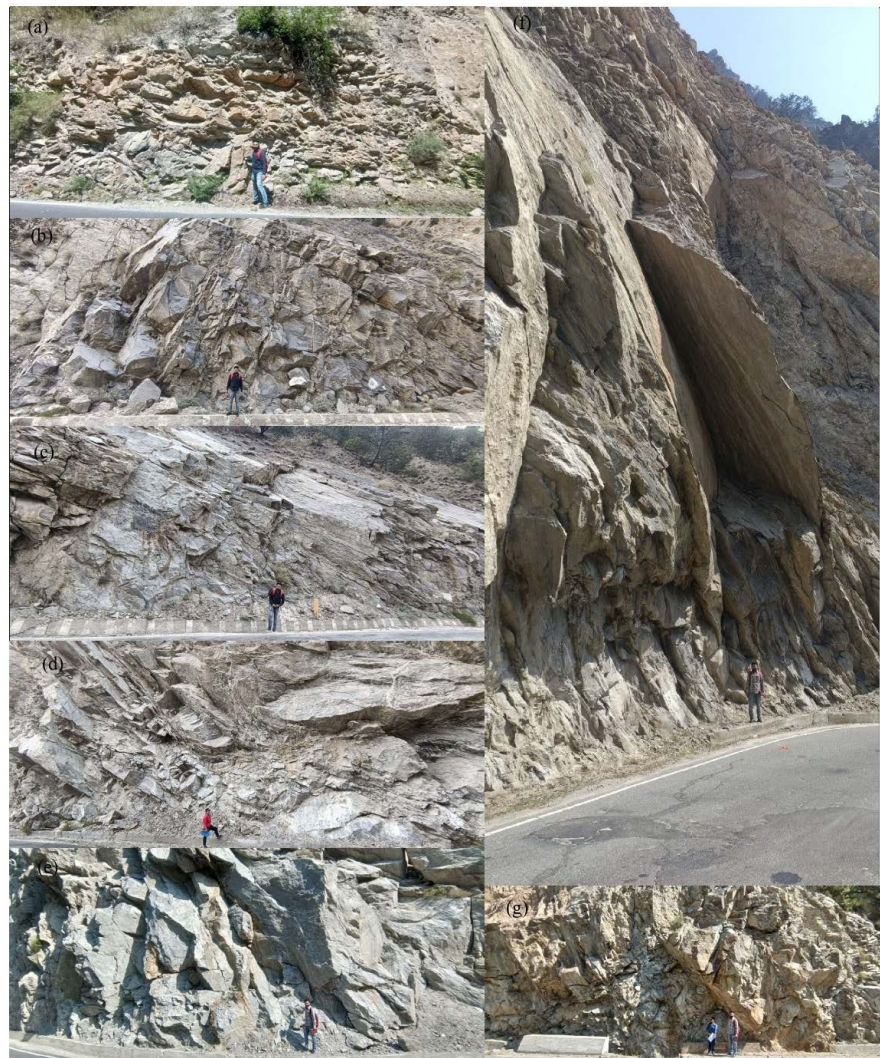
**Figure 3.** Field photograph of studied slopes: (a) S-1 jointed rock mass of gneiss. (b) S-2 jointed gneiss rock mass type. (c) S-3 planar failure in gneiss rock type. (d) S-4 wedge failure in jointed gneiss rock mass type. (e) S-5 wedge failure in gneiss rock mass. (f) S-6 shows wedge failure in granite-gneiss rock mass type. (g) S-7 planar and wedge failure in granite-gneiss rock mass.

Based on the detailed field observations of the study area, seven slopes were chosen to indicate the most common slope-instability situations observed along the analyzed highway corridor. Selection was based on slope geometry, lithology, degree of weathering, discontinuity features, indications of past instability, and probable influence on the highway. The geographical location and/or highway chainage of each slope were validated during the field studies. Even though the selected slopes do not include every slope throughout the corridor, they were chosen to reflect the primary geological, structural, and geomorphological factors associated with slope instability. A total of seven critical highway slopes that have been troubling the highway were identified for further investigation and analysis. The majority of the highway slopes were found fractured and jointed, dry and mostly barren, as indicated in the field photographs of the studied slopes in **Figure 3**. The stability assessments of the selected slopes were done using the RMR, SMR, and kinematics analysis. The RMR is calculated by adding the five given parameters [36] shown in **Table 2**. The compressive strength of the rocks is determined using field estimates [41], which comes in the low range, *i.e.*, 7 to 12. RQD is determined using the ( $J_v$ ) volumetric counting number of joints per cubic meter in the joint set using the formula suggested by [42]; the ratings for RQD obtained range from 8 to 13. Similarly, all other parameters like discontinuity spacing, joint condition, and groundwater conditions have been studied in the field, and calculated values are shown in **Table 2**. Adding all these five parameters.  $RMR_{basic}$  has been calculated for each of the seven slopes (**Table 2**). Adding all these five parameters.  $RMR_{basic}$  has been calculated for each of the seven slopes (**Table 2**). By applying [36] classification,  $RMR_{basic}$  values of 46, 59, 54, and 54 at the landslide locations S1, S2, S4, and S5, respectively, can be classified as fair rock. Similarly,  $RMR_{basic}$  values of 64, 68, and 64 at locations S3, S6, and S7, respectively, are classified as good rock. On steeper slopes, the bedding

plane can be daylighted from a wider range of angles throughout the slope face, leading to a higher failure rate than gentler slopes [43]. The slopes are generally steep to very steep ( $40^{\circ}$  -  $85^{\circ}$ ) throughout the study area, which, coupled with other favourable parameters, increases the likelihood of slope failure. The three joint sets (J0, J1, and J2) are mainly observed throughout the research area. **Table 3** shows the orientation of discontinuity and slope orientation data as well as substantially varied joint conditions of the selected slopes. The kinematic analysis performed on the selected slopes has helped to establish the mode of slope failure along NH-5 between Powari and Akpa, which was one of the prime aims of the study. Rock excavation for analysing the joints and discontinuity structures, whereas exposed outcrops from the road cuts selected to evaluate variation in the rock mass or mechanical and geological structure of the outcrops.
