# Late Migration of a Broken Trochanteric Cerclage Wire into the Abdominal Wall Three Years after Total Hip Arthroplasty: A Case Report

**How to cite this paper:** Hassoun, A., Tawk, C., El Hajj Moussa, M., Lahoud, J.C., Mehanna, S. and Hoyek, F. (2026) Late Migration of a Broken Trochanteric Cerclage Wire into the Abdominal Wall Three Years after Total Hip Arthroplasty: A Case Report. *Open Journal of Orthopedics*, 16, 532-540.

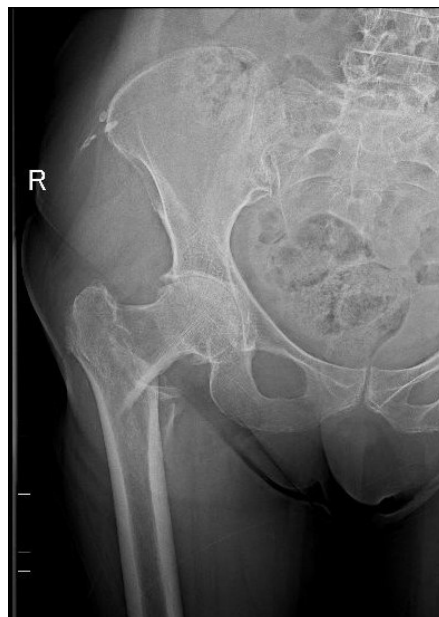
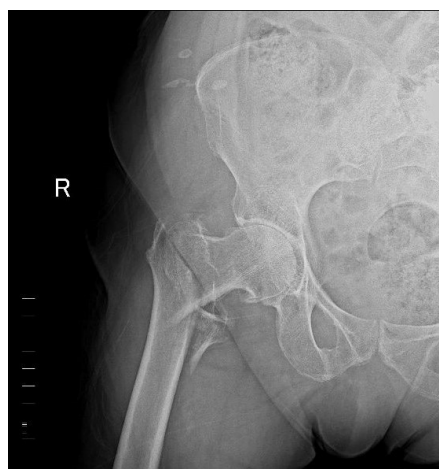
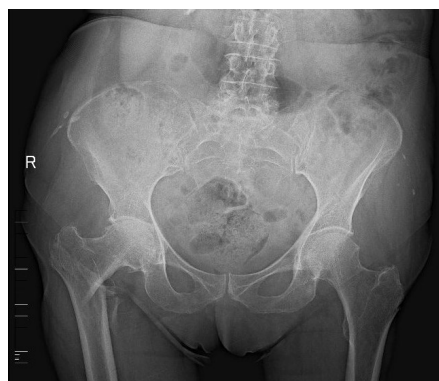
An 83-year-old woman with hypertension, dyslipidemia, chronic obstructive pulmonary disease, osteoporosis, and a previous cholecystectomy sustained a fall from standing height. Radiographs showed a right intertrochanteric fracture associated with advanced symptomatic hip osteoarthritis (**Figures 1-3**). Given the poor bone quality and pre-existing degenerative joint disease, primary THA was selected instead of internal fixation.

**Figure 1.** AP Radiograph of the right hip at presentation.

**Figure 2.** Lateral Radiograph of the right hip at presentation.

**Figure 3.** AP pelvic radiograph at presentation.

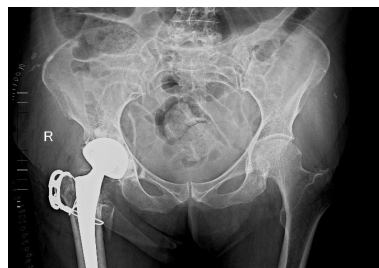
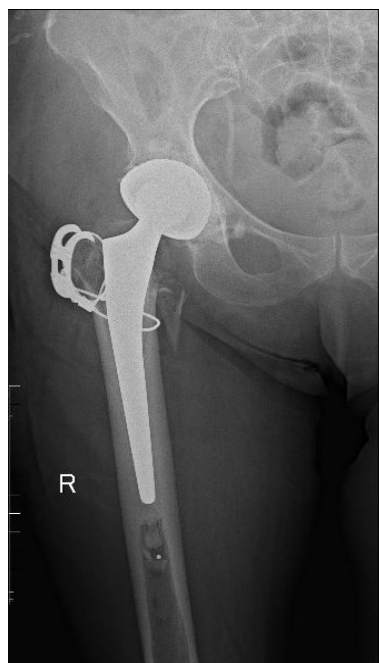
She underwent right THA with a double-mobility prosthesis. The greater trochanter was fixed with a trochanteric claw plate (DePuy Synthes) secured with four metallic cerclage wire loops. The immediate postoperative course was uneventful, and radiographs confirmed satisfactory implant positioning (**Figures 4-6**). The patient regained good function and remained asymptomatic for three years.

**Figure 4.** Post op pelvis AP radiograph.

**Figure 5.** Post op hip AP radiograph.

**Figure 6.** Post op lateral AP radiograph.

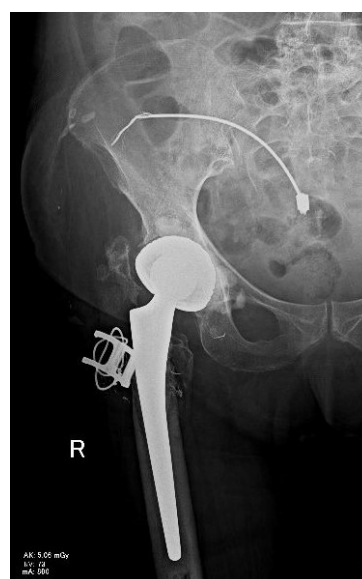
She then presented with abdominal pain and diarrhea. Anteroposterior pelvic and oblique radiographs were obtained; computed tomography (CT) was not performed. The radiographs showed that a broken segment of one of the four cerclage wires had migrated away from the greater trochanter and projected as a curvilinear radiopaque structure over the right iliac fossa, extending medially toward the pelvic inlet (**Figures 7-9**). The remaining three wire loops were intact, the claw plate was in place, the greater trochanter was united, and the femoral stem and

**Figure 7.** Pelvis AP radiograph three years after surgery showing the broken cerclage wire.

**Figure 8.** Hip AP radiograph three years after surgery showing the broken cerclage wire.

**Figure 9.** Hip lateral radiograph three years after surgery showing the broken cerclage wire.

acetabular component were stable, without radiographic signs of loosening. Because cross-sectional imaging was not obtained, the relationship of the fragment to the abdominal viscera, the iliac vessels, and the layers of the abdominal wall could not be determined preoperatively. Work-up for other causes of abdominal pain and diarrhea was negative.

The patient underwent surgical exploration of an abdominal wall eventration by a combined team of an orthopaedic surgeon and a general surgeon. The wire fragment was found entirely contained within the abdominal wall. The peritoneum was intact, the fragment had not entered the peritoneal cavity, and no visceral injury was identified. The fragment was removed and the abdominal wall was repaired with mesh. No hip hardware was removed, as the remaining trochanteric construct and the arthroplasty components were stable.

Removal of the fragment was indicated because it was symptomatic, sharp, and located close to the peritoneal cavity. Removal through the abdominal wall, combined with repair of the eventration, addressed both problems in a single procedure, and the stable, united trochanteric construct did not require revision. Before removal of migrated hardware close to the pelvis or abdomen, cross-sectional imaging is advisable; for intrapelvic implant protrusion, CT angiography has been recommended to plan the surgical approach [9]. In our patient, CT was not performed, and the extraperitoneal location of the fragment was established only at surgery. This is a limitation of the report.
