# The Effect of Anion-Exchange-Treated Water Containing Phosphonic Acid and Benzotriazole on Copper Corrosion Resistance

Copper, Carbon Film, pitting Corrosion, Anion Exchange-Treated Water, Benzotriazole, Phosphonic Acid

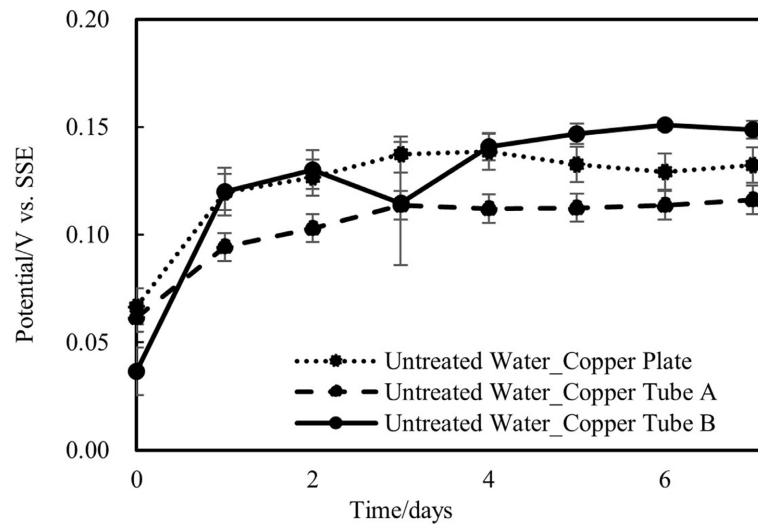
For untreated water, the corrosion potential of all test specimens increased sharply immediately after immersion. Subsequently, the corrosion potential continued to increase gradually. Untreated water contains corrosive ions such as Cl<sup>-</sup> and SiO<sub>4</sub><sup>2-</sup>. It is considered that these corrosive ions promoted corrosion reactions, causing the corrosion potential to rapidly increase. These reactions formed

an oxide film on the surface of the test specimen, which is suggested to have caused the corrosion potential change to become more gradual.

**Figure 3.** Time-Dependent changes in the corrosion potential of test specimens in test solutions of untreated water. (Stirred at 300 rpm, under room temperature, open-air conditions.)

The measurement results of the corrosion potential are shown in **Figure 3** and **Figure 4**. This shows the average of three measurements.

Yamada *et al.* reported that the carbon film formed unevenly on the inner surface of the copper tube [1]. It has also been reported that the coated carbon film areas act as the cathode, while the uncoated copper substrate areas act as the anode [3]. Copper tube A has a low residual carbon amount, suggests that the cathode area on the test surface is small and unevenly distributed. Therefore, it is considered that the initial corrosion potential rise during immersion was smaller for copper tube A than for the copper plate and copper tube B. On the other hand,

copper tube B has a high residual carbon amount relative to the test area and a large cathode area. For this reason, it is considered that cathodic reactions proceeded rapidly immediately after immersion, causing the corrosion potential to rise sharply.

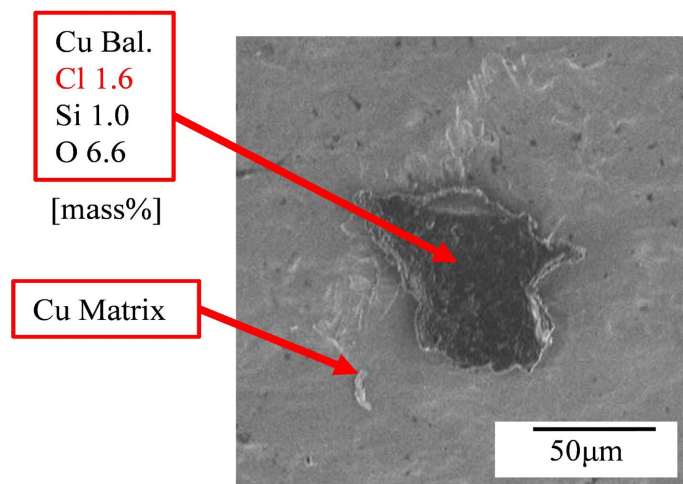
**Figure 6.** SEM image and the EDX analysis of copper tube B after measurement of corrosion potential with untreated water.

The results of surface observation and analysis are shown in **Figure 5**. In untreated water, greenish-blue corrosion products were observed, regardless of the residual carbon amount. However, in the treated water, greenish-blue corrosion products were not observed, regardless of the residual carbon. **Figure 6** shows SEM images and the results of the EDX analysis for areas where corrosion products were observed and where they were not observed. In the corrosion products, 1.6 mass% of Cl was detected. In the copper base metal areas without corrosion products, Cl was not detected. The area beneath the corrosion was not observed to be pitted. This is considered to be due to the short test period. It has been reported that pitting corrosion of copper tubes progresses due to the influence of  $\text{Cl}^-$  [13]. Kano *et al.*'s EDX analysis of the pitting area confirmed the accumulation of Cl [14]. Although no pitting was observed directly beneath the corrosion products, the EDS analysis detected  $\text{Cl}^-$  in the corrosion products. These results are considered consistent with the early stages of pitting corrosion and suggest indications of pitting corrosion occurrence.

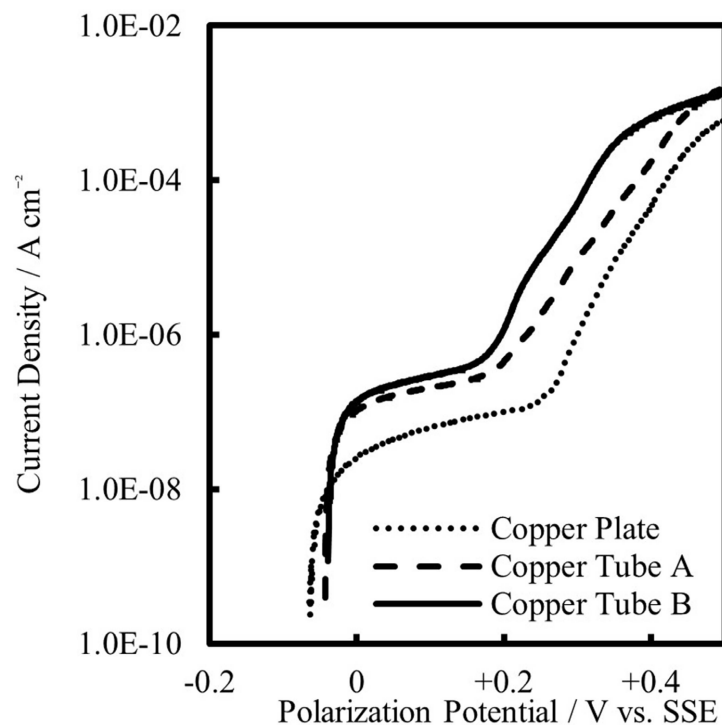
The results of the anodic polarization curve measurements are shown in **Figure 7** and **Figure 8**. The measurement was performed three times. A similar trend was observed in all these measurements. The data from one of these measurements are shown. For untreated water, the current density increased sharply starting around  $-0.05$  V vs. SSE, regardless of the amount of residual carbon. It then stabilized near 0 V vs. SSE, and the current density gradually increased. Subsequently, for all specimens, the current density increased sharply again starting from around  $+0.2$  to  $0.3$  V vs. SSE. The polarization potential at which the current density sharply increases

again is defined as the Break down potential (BDP). The BDP increased in the order copper tube B < copper tube A < copper plate, and a higher amount of residual carbon tended to cause it to occur on the less noble potential side.

**Figure 7.** Anodic polarization curves of test specimens in test solutions of untreated water (sweep speed 20 mV/min, stirred at 300 rpm, at room temperature, deoxidized by nitrogen gas.)

2) In the anodic polarization curve measurement of untreated water and treated water, untreated water showed a tendency for current density to increase sharply at the noble potential side, regardless of residual carbon amount. In the treated water, a rapid increase in current density was not observed on the noble potential side.

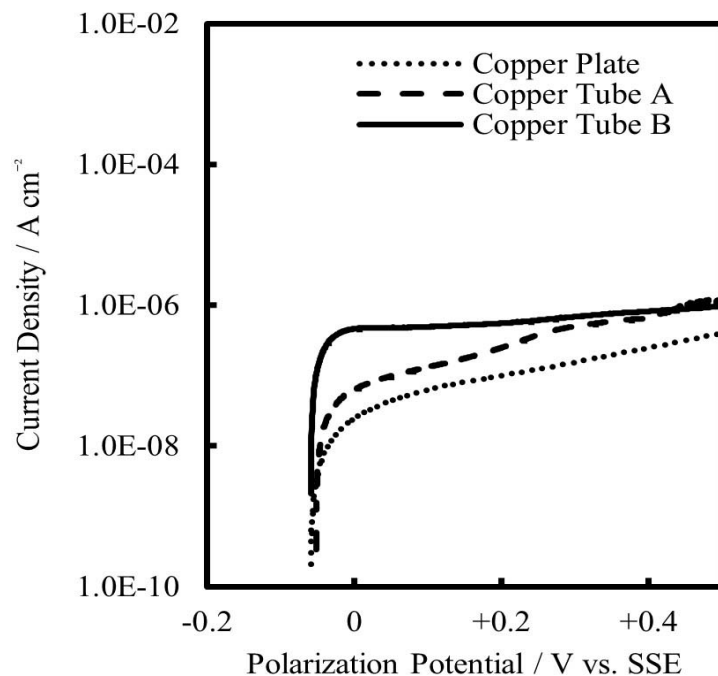
For treated water, the current density increased sharply from around  $-0.05$  V vs. SSE, regardless of the residual carbon amount. Subsequently, for all specimens, the current density stabilized near 0 V vs. SSE. The BDP could not be observed, and the current density could be different.

**Figure 8.** Anode potential curves of test specimens in test solutions of treated water. (Sweep speed 20 mV/min, stirred at 300 rpm, at room temperature, deoxidized by nitrogen gas.)
