# Mechanical Failure of Internal Fixation and Arthroplasty Implants in the Department of Orthopaedics and Traumatology, Bouaké University Hospital, Côte d'Ivoire

Department of Orthopaedic Traumatology, Bouaké University Hospital, Bouaké, Côte d'Ivoire

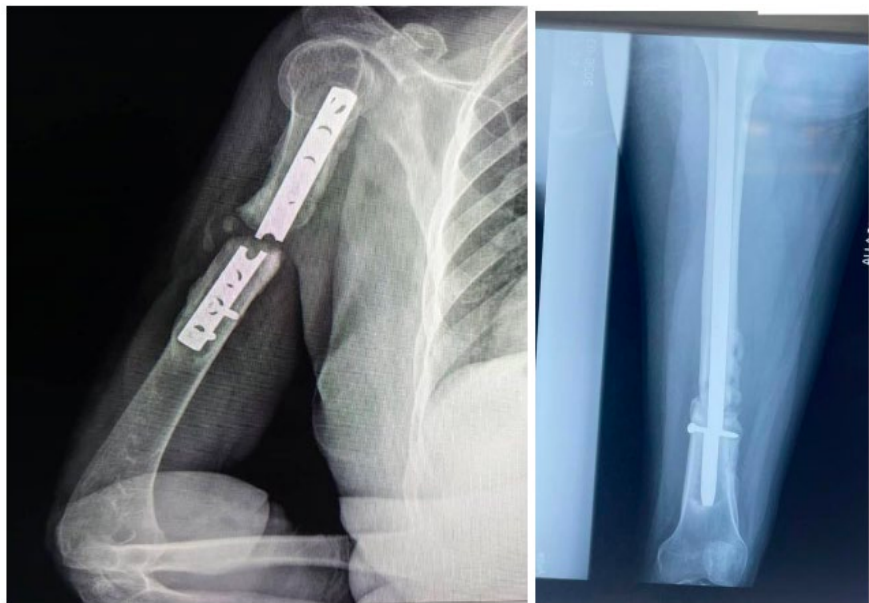
**Figure 1.** Radiograph showing mechanical failure (A, B). A: radiograph of the arm showing plate breakage following humeral osteosynthesis; B: radiograph of the thigh showing breakage of the intramedullary nail.

The mean time to occurrence of mechanical failure was  $75 \pm 37$  days (range 35 - 120). The distribution of the various types of mechanical failure is summarised in **Table 1** (**Figure 1**). The distribution of patients according to the cause of failure is summarised in **Table 2**.
